RLink Lite/RLink J2534 Case Study

GM Tailgate Support Bar Fault Case

**How to Use TOPDON RLink Lite/RLink J2534 and GDS2
to Perform GM Diagnostics**

Vehicle Information: 2012 Cadillac SRX car, with a driving mileage of 145,662 kilometers.

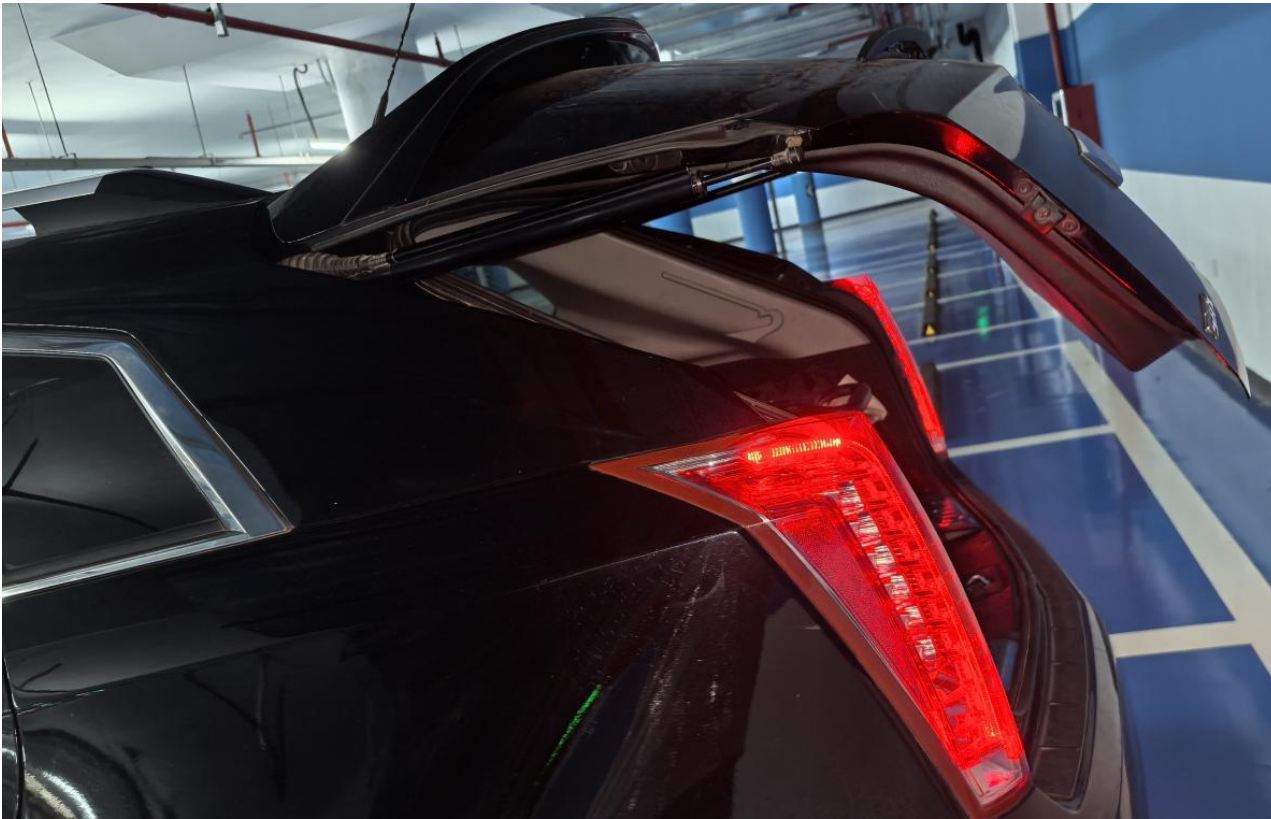
1. According to customer feedback, check and confirm that the tailgate is opened and then slowly closed automatically.
2. Use the GM OEM software to check and find that the tailgate is not calibrated.

After the tailgate is opened, it automatically falls back and closes.

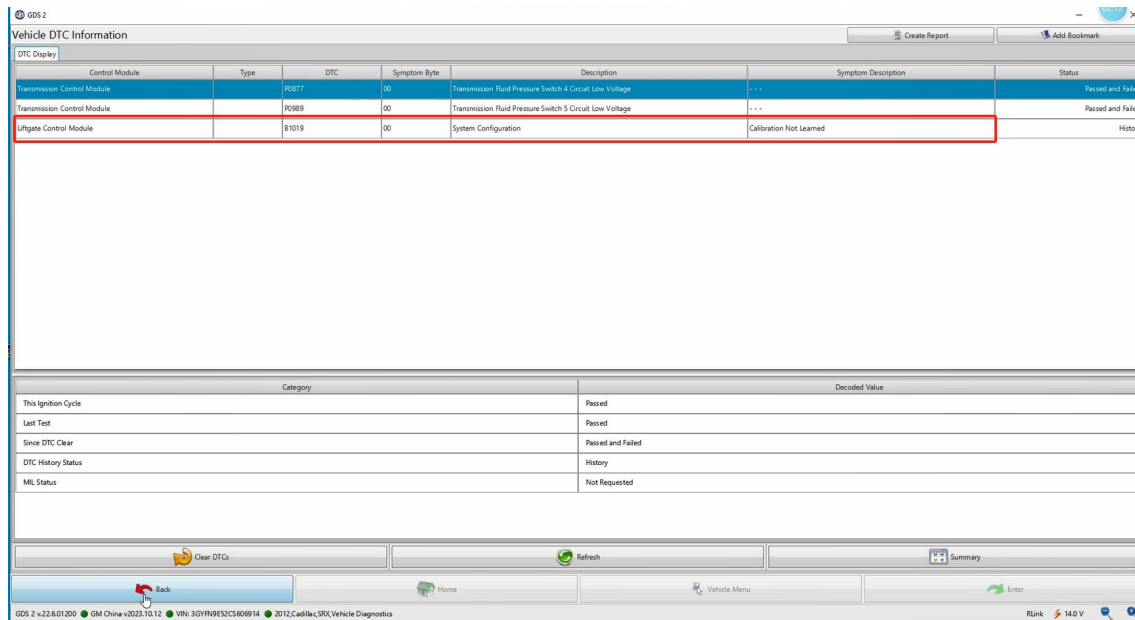
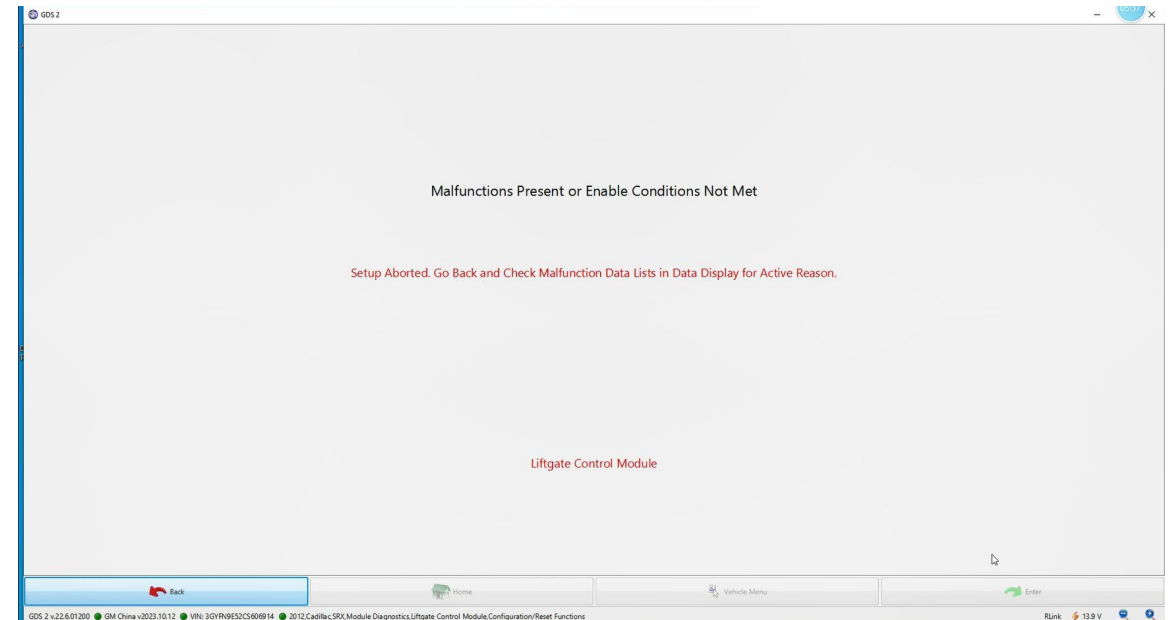
- I. After the diagnostics are completed, a liftgate not calibrated fault is detected, and the fault displays “Liftgate Control Module - System Configuration - Calibration Not Learned”.
- II. Recalibrate the tailgate, but the calibration was unsuccessful.
- III. Fault Cause Analysis
 - ① Internal damage to the strut causes abnormal operation.
 - ② Insufficient hydraulic oil in the strut causes insufficient strength.
 - ③ The hydraulic pump of the strut is worn, resulting in insufficient working force.

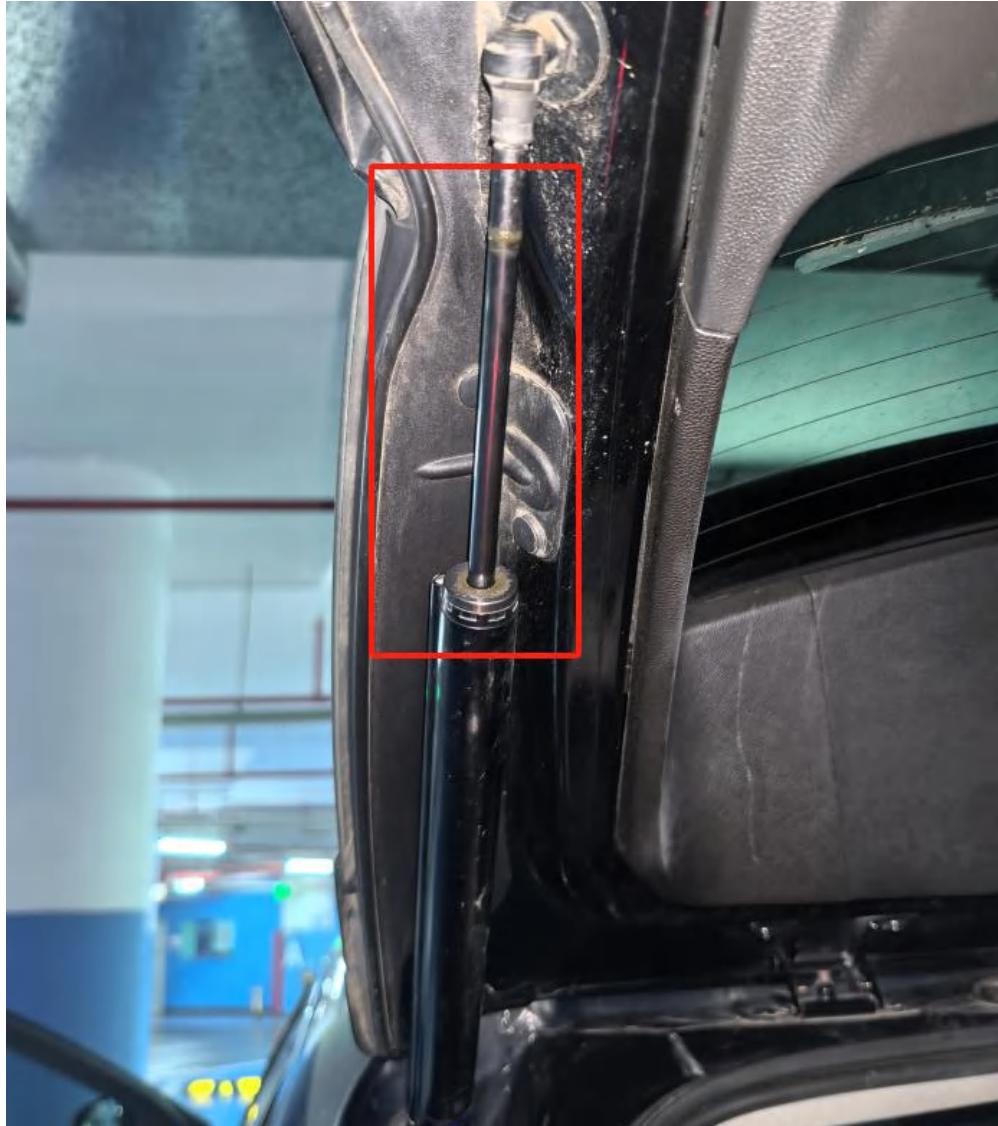
- I. Remove the right mechanical strut for testing, and no oil leakage was found. Test the working pressure of the strut and it is normal.
- II. Check the left hydraulic strut and find oil leakage.
- III. Remove the left hydraulic strut for testing, and find that the strut strength is insufficient. Confirm that the hydraulic strut is damaged.

IV. After replacing the hydraulic strut, recalibrate the tailgate. Click Module Diagnostics and click Enter. Then click Liftgate Control Module and click Enter. After that, click Configuration/Reset Functions and click Enter. Click Continue to finish calibration.
